Beaver Creek Fish Kill Event

August 2023

Seneca Valley Trout Unlimited January 22, 2024

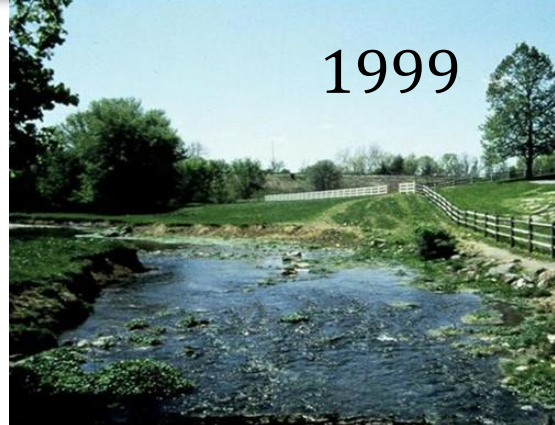
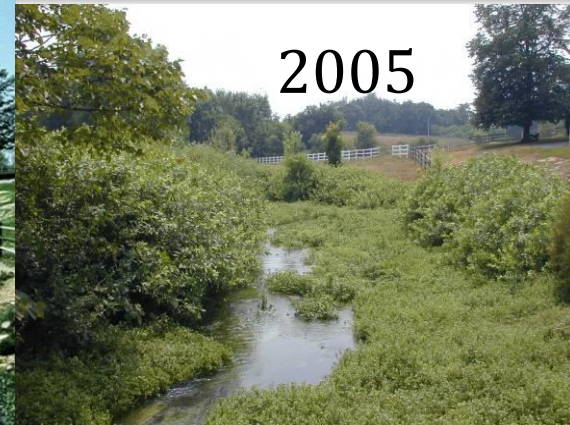
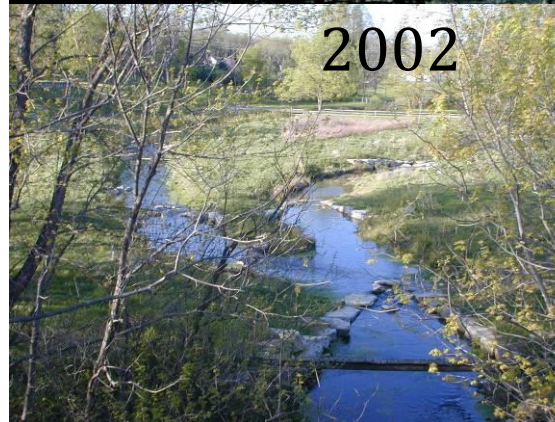
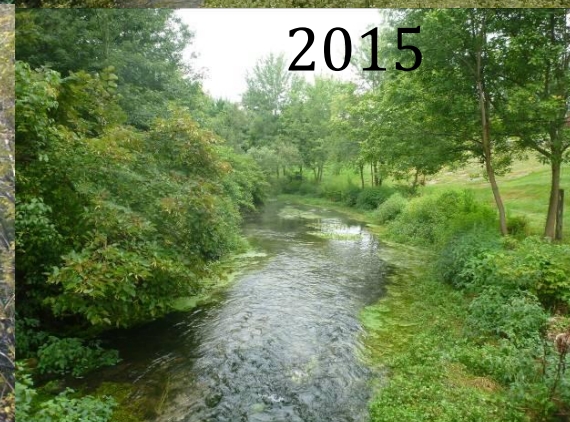
Restoration efforts included many partners and projects throughout the watershed.

- Streambank stabilization
- Reduce width:depth ratio
- Improve riffle:pool ratio
- Natural channel design
- Add in-stream habitat features such as large rocks and woody debris
- Riparian buffer planting
- Cattle exclusion fencing

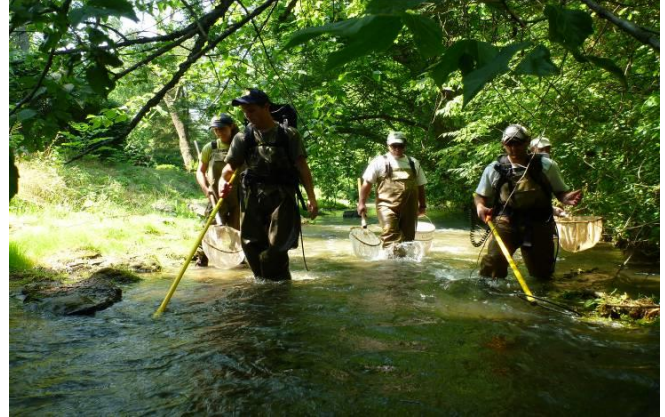
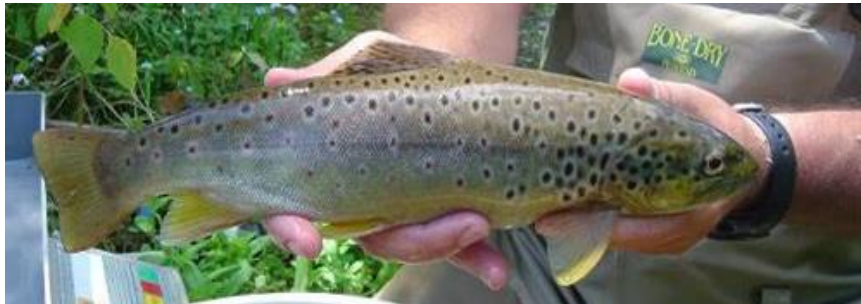
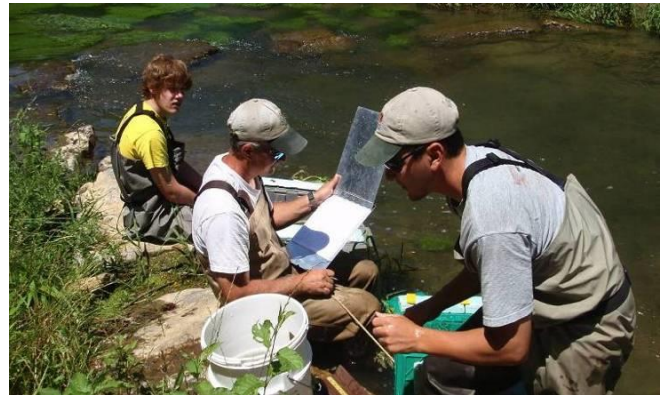
- The department planned annual Beaver Creek electrofishing surveys on August 8, 2023.
- Surveys are conducted annually to monitor the brown trout population.
- Multiple pass depletion surveys. Trout are collected, counted, measured for total length and weight, and returned to the stream.
- Population estimates are calculated from results.

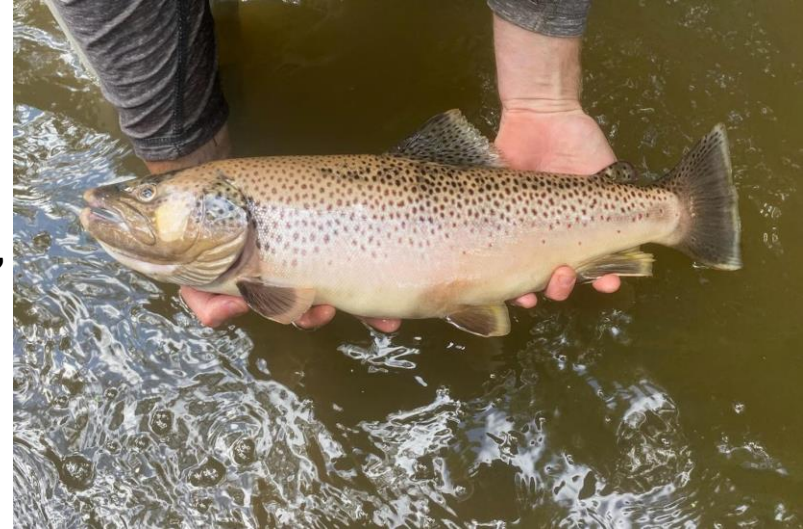
- Dead trout were observed at the start of the first survey at the Beaver Creek Fishery Management Area.
 - 40 dead trout were counted in 100 meters from the start of the survey station.
 - Most of the mortality was adult brown trout, though other fish species were observed.
 - Survey activities were canceled and Maryland Department of the Environment was contacted.
- A plan to conduct qualitative electrofishing surveys was developed.

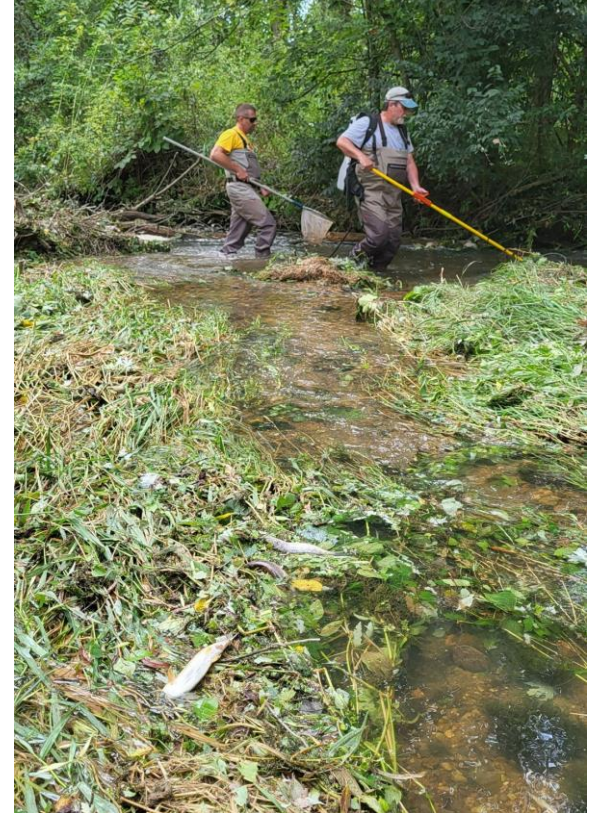
- Initial investigation attempted to determine extent of impacts and identify possible cause.
 - Dead trout were observed from Route 40 upstream to the spring channel at Albert Powell Trout Hatchery.
 - They were not observed in or above the spring channel or in Black Rock Creek.
 - Live trout were captured below Route 40.
 - Water quality parameters were consistent with historical data.
 - Fish health staff at the Oxford Cooperative Laboratory found no evidence of infectious disease.
- Full extent of loss could not be determined due to high flows and turbidity from storm on August 7. ~ 400 dead trout were observed.

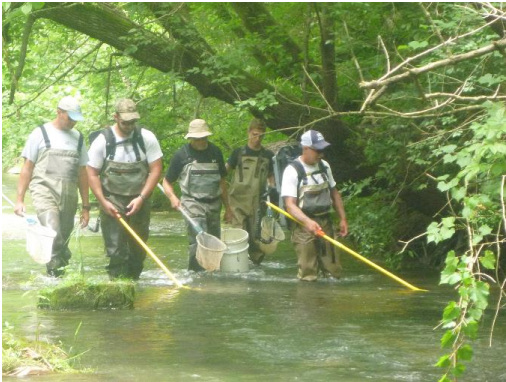
Quantitative surveys were conducted at historic stations on August 15 and 16 to determine impacts to the population.

- 10 surveys in Beaver Creek and Little Beaver Creek.
- Multiple pass depletion surveys in 75+ meter stations.

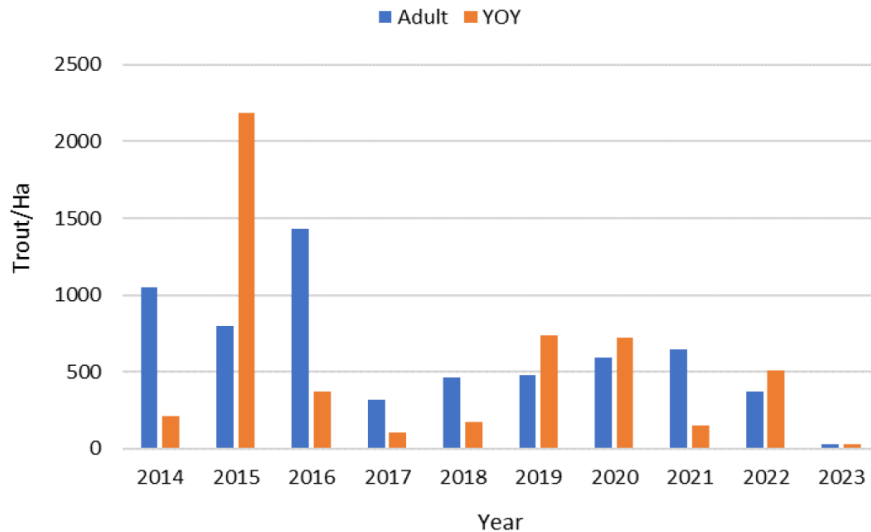
3. Lower section of Beaver Creek Fishery Management Area.
 - a. Several live trout observed (4 adults, 4 YOY).
 - b. Very low abundance when compared to historic data
